**REPORT ON FULL SCALE LABORATORY TESTS ON  
TRIPSTOP™ PVC JOINERS FOR RESIDENTIAL CONCRETE  
PAVEMENT (FOOTPATH / SIDEWALK) OF 125 mm  
THICKNESS**

**Y.M. Xie, S. Setunge and Y.C. Koay**  
School of Civil and Chemical Engineering  
RMIT University, Melbourne, Australia

Research Report No.: **RMIT/TS/7**

12 July 2006

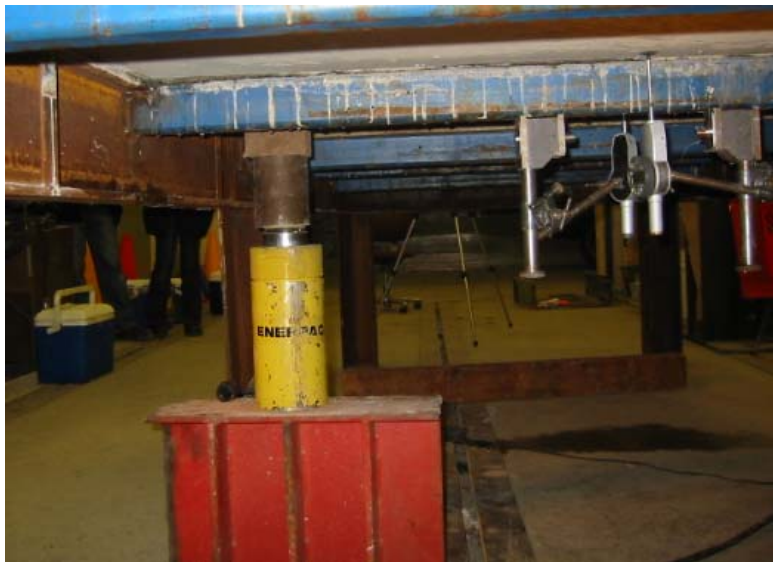
Figure 6. Slab 2 being pushed up at a corner

With the previous tests, the slabs were moved up almost uniformly across the width, resulting in a uniform distribution of force on the TripStop™ PVC joiner. A more challenging case would be the one where Slab 2 is pushed up at a corner as shown in Figure 6.

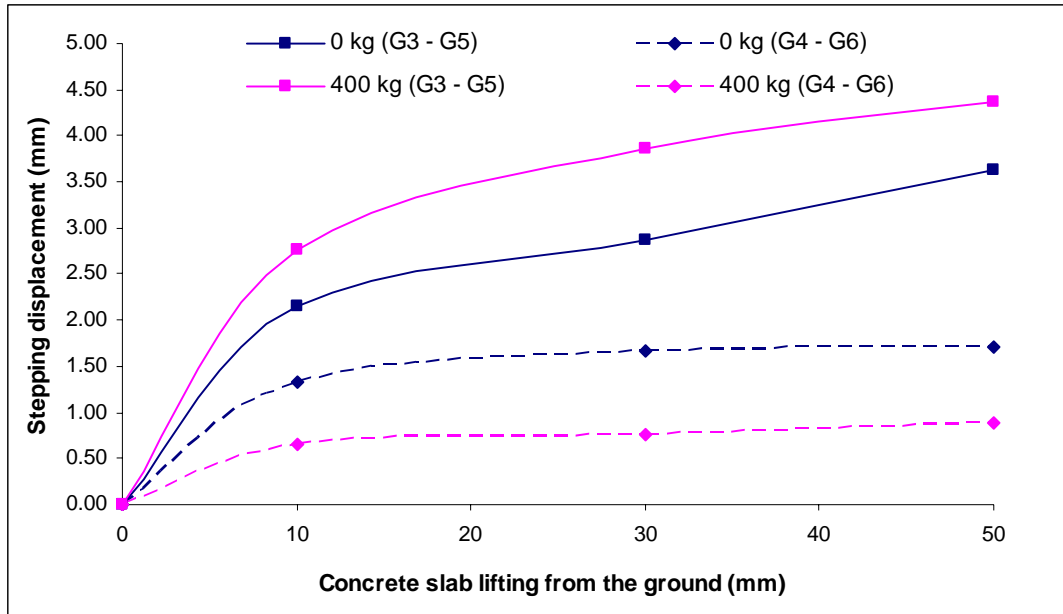
Figure 8. Stepping displacement when jacking up at point D.

It is seen that the stepping displacement with no additional load near G3 (where the jacking force was applied) was 3.64 mm. On the other side of the slab, the stepping displacement was 1.71 mm. This indicates that the slabs were slightly tilted due to Slab 2 being pushed up at a corner.

The last test on Joint 2 was the most challenging one where a 400 kg concentrated load was applied. Figure 9 shows such a set-up. The hydraulic jack pushed up Slab 2 at point D and the 400 kg concentrated load was applied to point C in Slab 1 (refer to Figure 7). To assess the performance of TripStop<sup>TM</sup>, the 'worst scenario' load case was where one slab was pushed up at a corner while a concentrated load was applied next to it on the adjoining slab. The maximum stepping displacement at G3 was 4.36 mm, while on the other side of the slab the stepping displacement was 0.88 mm.

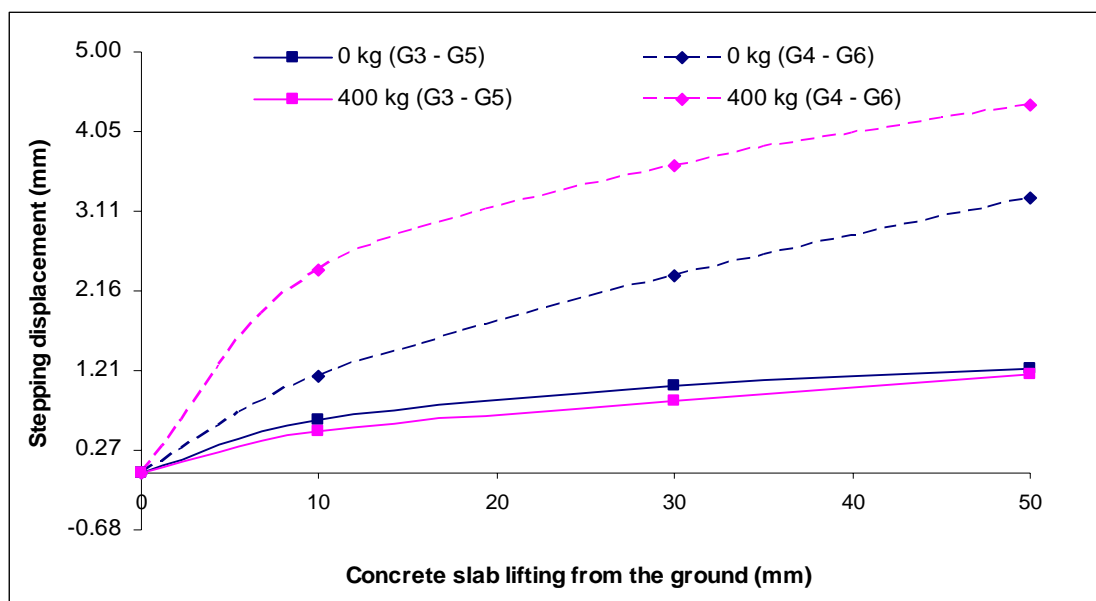
Figure 13. Stepping displacement when jacking up at point G.

When there was no additional dead load on the slabs, the maximum stepping displacement was 3.27 mm which is similar to the result of test on Joint 2 (3.64 mm). When a 400 kg concentrated load was applied to point H, the maximum stepping displacement was 4.37 mm which is also similar to the result of test on Joint 2 (4.36 mm).
