Comparison of Various Types of Shear Connectors for Minimizing Tripping Hazards in Concrete Footpaths

Abstract

In this study, three types of joiners (connectors) made of aluminium, EPDM rubber and PVC have been studied to examine their capability for minimizing the tripping hazard.

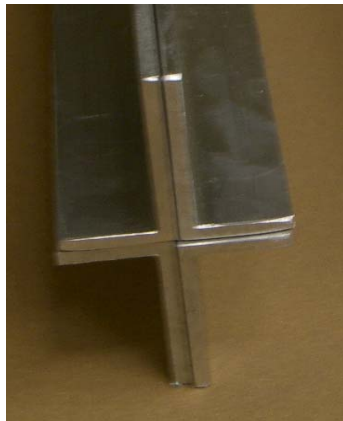
(a) Aluminium joiner

The shape and cross section of each of the joiner strips is shown in Fig. 1. Aluminium joiner is formed by four 20 x 37.5 x 3 mm unequal angles revetted connection on both angles. EPDM and PVC joiners are made from ethylene-propylene-diene terpolymer (same rubber as used for the car tyres) and plastic, respectively.

Fig 1. Types and cross section of joiner strips

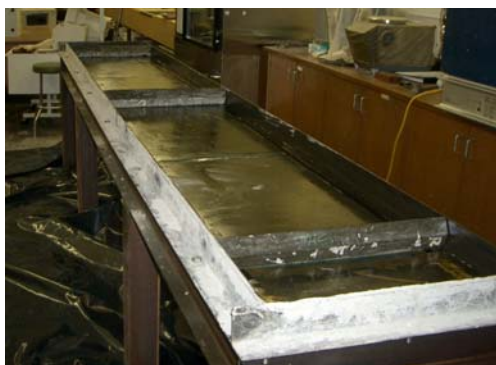
(a) First type - 0.5 m x 3.5 m

In order to save time to wait for concrete curing at 28 days and testing, two testing frames have been designed and fabricated. Both testing frames were designed to simulate tree root invasion or soil movement so that the formwork can be removed from underneath the concrete slabs and concrete slabs can be jacked up from virtually any point by the use of a hydraulic jack. Additional loads will be added to the top surface of the slab (using standard weights) to simulate the weight of pedestrians or vehicles. The difference between the two types of testing frames are shown in Fig 2 and discussed below:-

This testing frame is 0.5 m wide and 3.5 m long. It has been designed to have *two full scale slabs* in the middle plus two smaller slabs (one at each end). The set-up allows for *three joints* between the slabs where the joiner strip can be installed during the concrete pour. *One joiner* connecting the *two full slabs* was tested, as they closely represent the conditions of a footpath of “infinite” length. Aluminium joiner was cast and tested on this testing frame.

Fig 2. Testing frame

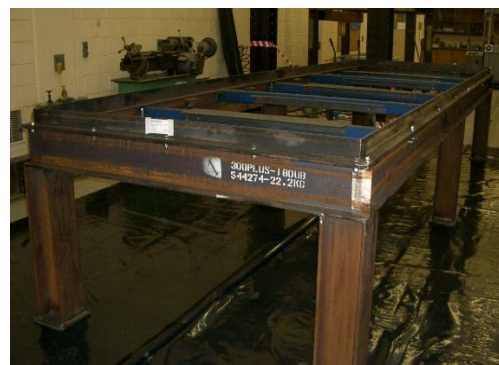
(b) Second type – 1.5 m x 5.0 m

This testing frame is 1.5 m wide and 5 m long. It is large enough to have *three full scale slabs* in the middle plus two smaller slabs (one at each end). The set-up allows for *four joints* between the slabs where the joiner strip can be installed during the concrete pour. The *two joiners* connecting the *three full slabs* were tested, as they closely represent the conditions of a footpath of “infinite” length. EPDM rubber and PVC joiners were cast and tested on this testing frame.

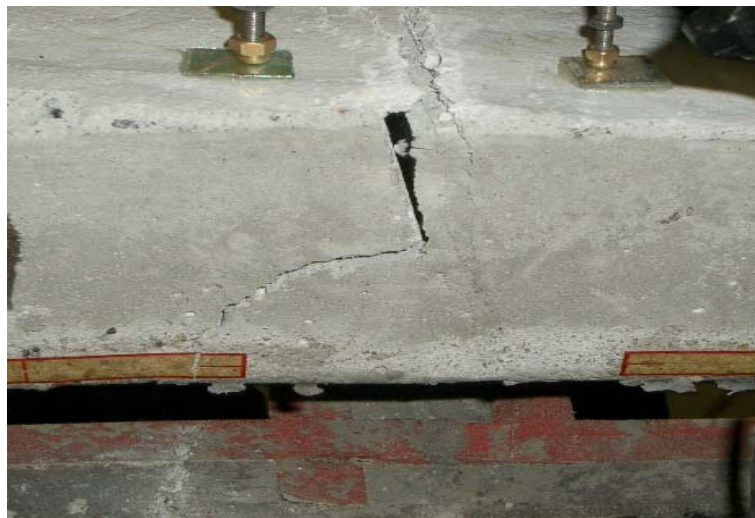
From the Fig 5, it is apparent that added load on the concrete slabs would increase the stress level in the aluminium joiner. In the test, due to the high stresses between the concrete and aluminium joiner, the cracks occurred at the edge of the surface of the concrete as shown in Fig. 6.

Fig 6 Crack occurred at the shape edge of aluminium Joiner

The joiner should not be too rigid or too soft. If the joiner is too rigid it would cause high stresses between the joiner and concrete. If the joiner is too soft, the total stepping displacement (including creep) could exceed the allowable limit. Further investigations on the optimal materials and profiles for the joiners are underway.

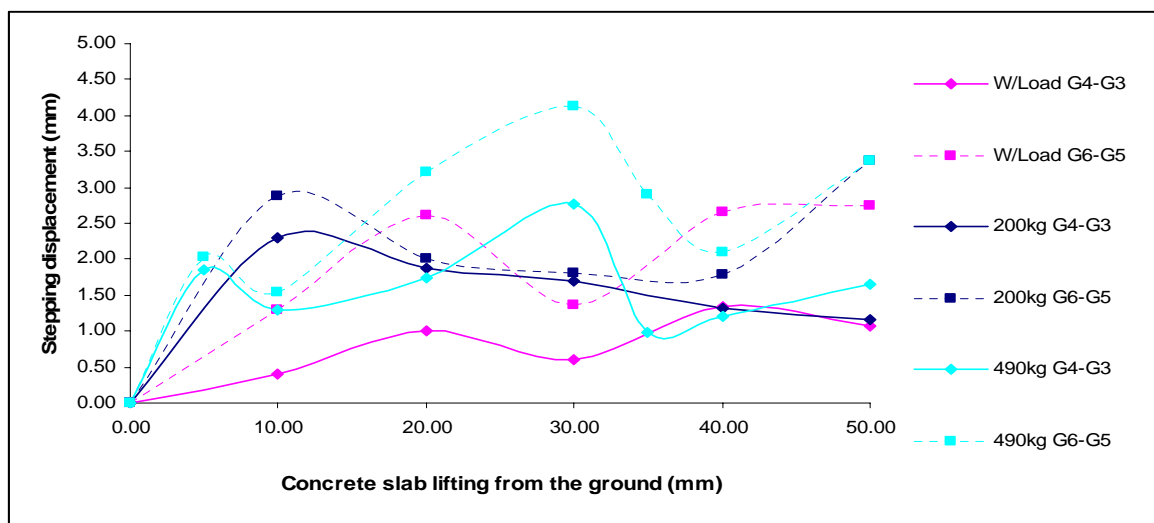
The test of the EPDM Rubber joiner was similar to the aluminium joiner except that the testing frame was wider and large enough to have three full scale slabs (Refer to Fig 4). The self weight of each slab was about 400 kg. The results of the testing are shown in Table 3 and Fig 7.

It is clear that the characteristic of the EPDM rubber joiner is quite different to the other two rigid materials investigated. The curves of stepping displacement showed an irregular pattern indicating displacement and recovery upon further lifting. It is because EPDM rubber is a hyperelastic material. Overall maximum stepping displacement did not exceed 4.5 mm. Stress-strain creep properties of rubber needs to be measured and the joiner stress needs to be understood to be able to predict the observed behaviour.

In the first test, no additional load was applied on the slab; the maximum stepping displacement was 1.07 mm, which happened when the corresponding displacement measurement on the other side of the slab was 2.75 mm. This indicates that the slabs were slightly tilted which possibly was because the jacking force was not exactly at the centre. The average stepping displacement of 200 kg load on the slab 3 varied from 1.15 mm to 3.37 mm. The added 200kg load would increase the stress level in EPDM rubber joiner 3 by approximately 15 – 20 % compared to no additional load.

The last test was the same as the previous two tests except that the loading on Slab 3 was now increased to 490 kg. It is seen that despite the excessive loading on the slab, there was very little increment in the stepping displacement compared to the results of no additional load and 200 kg on the slab 3. The stepping displacement in this test varied from 1.21 mm to 3.37 mm, which was similar to that of previous tests where the loading was much smaller.

Fig 7 EPDM Rubber Joiner testing results

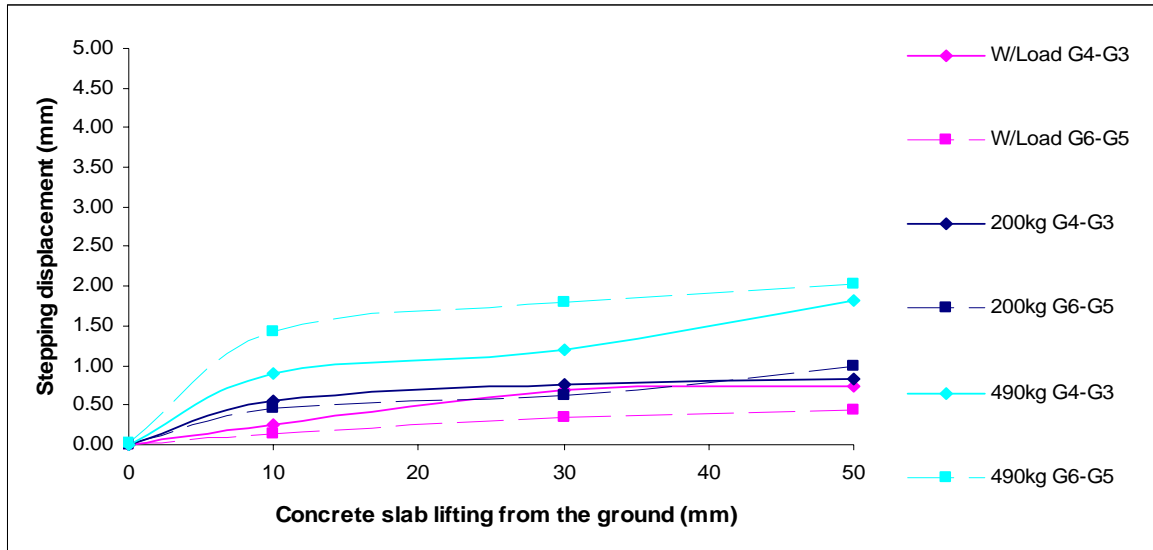
Similar test work was carried out on the PVC Joiner. The results of the testing are shown in Table 4 and Fig 8. We can see that the added load would increase the stepping displacement level in PVC joint 3. The trend of the curve as shown in Fig 8 was very similar to that of the Aluminium Joiner. The average stepping displacement with no additional load varied from 0.13 mm to 0.73 mm, while 200 kg load on slab 3 varied from 0.47 mm to 0.98 mm and 400 kg load on slab 3 varied from 0.91 mm to 2.03 mm.

Fig 8 PVC Joiner testing results

Note that in this test, the maximum stepping displacement was 2.03 mm which is the lowest when compared to 2.91 mm and 3.37 mm of the aluminium and the EPDM rubber joiners. Therefore, the PVC joiner was shown to offer the best load transfer between slabs which reduce the stepping displacement or vertical movement.
